# RUSSIAN INTERIM REPORT DETAILS LAST MOMENTS OF FLYDUBAI BOEING 737 CRASH AT ROSTOV

**The Russian Interstate Aviation Committee published an interim report, detailing the progress of their investigation into the cause of the fatal accident involving the flydubai Boeing 737-800 at Rostov Airport on March 19.**

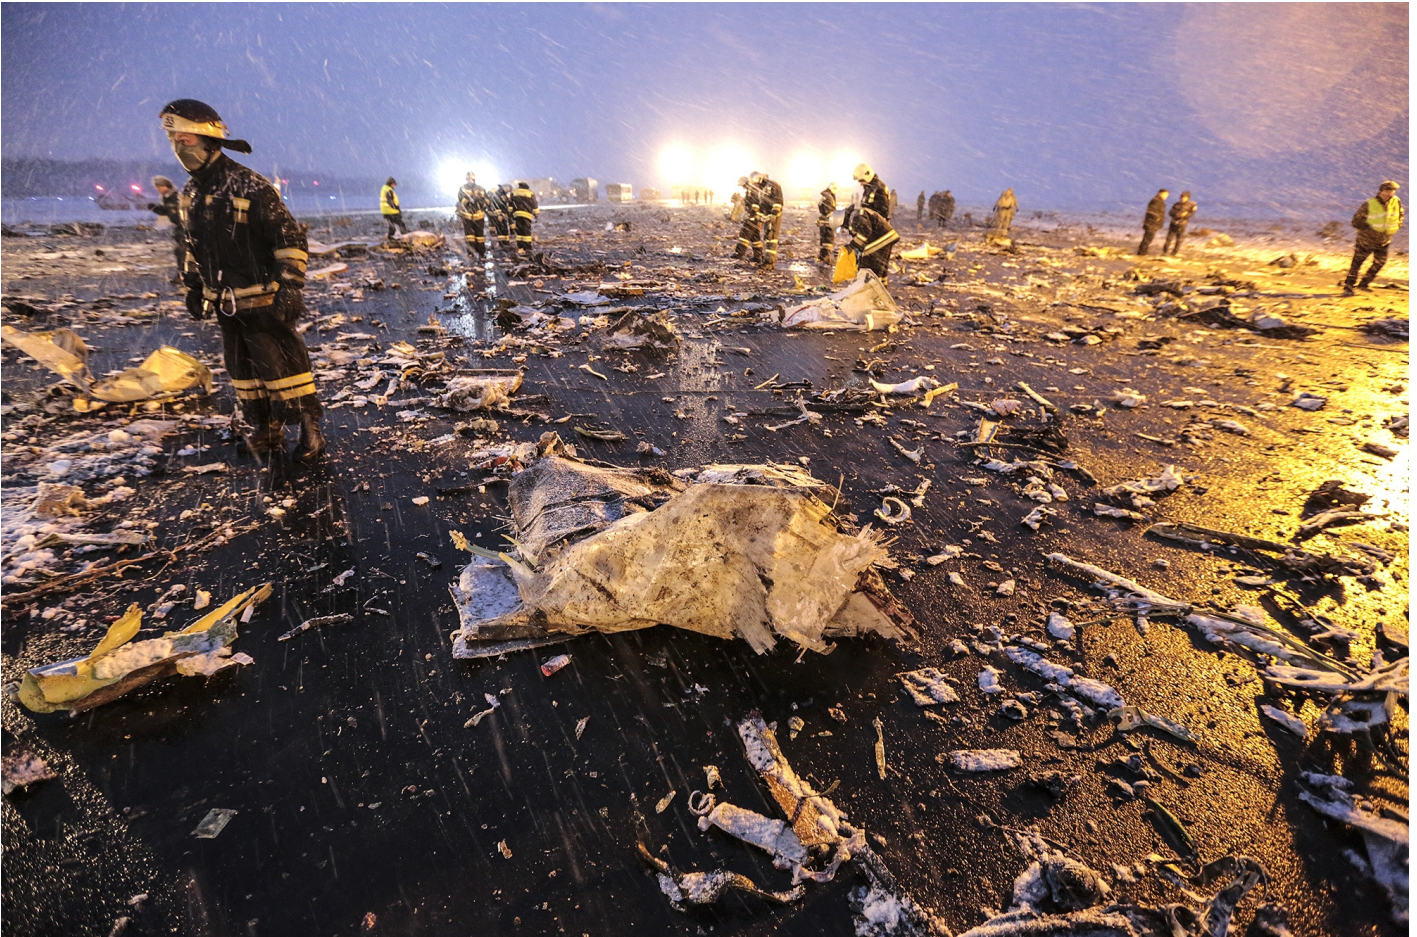
## Reconstruction of the aircraft (IAC)

At a height of 900 m there was a simultaneous control column nose down input and stabilizer nose down deflection from -2,5 deg (6,5 units) to +2,5 deg (1,5 units). The FDR recorded a nose down stabilizer input from the stabilizer trim switch of the control wheel lasting 12 seconds, while the CVR record contains a specific noise of rotation of the trim wheels located on both sides of the central pedestal. As a result the aircraft, having climbed to about 1000 m, turned into descent with a negative vertical acceleration of -1g. The following crew recovery actions did not allow to avoid an impact with the ground.

The aircraft hit the runway about 120 m from the threshold with a speed of over 600 km/h and over 50 degrees nose down pitch.

IAC recommends among others to give pilots additional training on elements of go-arounds in various conditions, in manual control mode with two engines operative from various heights and with insignificant flight weights.
